USAAVLABS TECHNICAL REPORT 71-7

DETERMINATION OF PHYSICAL AND STRUCTURAL PROPERTIES OF MIXED-MODULUS COMPOSITE MATERIALS

**EUSTIS DIRECTORATE
U. S. ARMY AIR MOBILITY RESEARCH AND DEVELOPMENT LABORATORY
FORT EUSTIS, VIRGINIA**

**THE BOEING COMPANY,
PHILADELPHIA, PENNSYLVANIA**

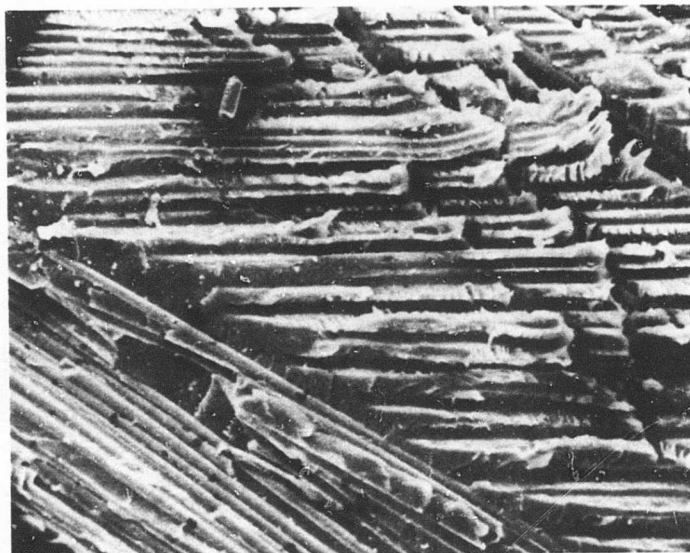
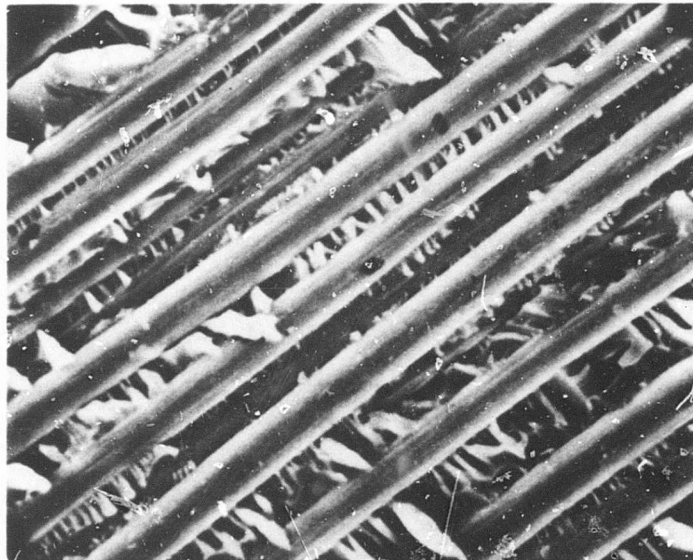
(a) 190X GRAPHITE (—) S-GLASS (\)

(b) 200X GRAPHITE (—) S-GLASS (\)

Figure 50. Scanning Electron Micrographs of a Failure Surface from a Static Mixed-Modulus Deflection Specimen.

(c) 380X S-GLASS

(d) 390X GRAPHITE (—) S-GLASS (/)

At low optical magnifications, the interface fractures appeared to have isolated patches of the opposing composite's resin and fibers left clinging to the surface. The SEM investigation not only verified this observation (Figures 50a, 50b, and 51b) but also revealed a large number of denuded S-glass and graphite fibers (Figures 50 and 51). A fracture parallel to the interface would naturally result in a large number of exposed fibers. The extent to which the fibers are denuded here indicates that the fiber-resin interface bond was the weak link in both the graphite and glass systems.

The results indicate that the cohesive strength of the composite exceeded the adhesive strength for both resin systems. This is observed on the normal fracture surface of Figures 50c, 50d, and 51e, in which the crack is shown to predominantly follow the resin-fiber interface. If the reverse were true, i.e. the adhesive strength were greater than the cohesive strength, the failure surfaces would tend to be more planar. These same micrographs also confirm good resin penetration of the fiber strands; hence, the excessive number of denuded fibers cannot be attributed to this source. One further point concerning resin incompatibility can be raised. Figures 50a and 50b contain no evidence of resin mismatch, since the failure plane is shown not to reside at the BP907 - 1002 resin interface. Rather, the fracture has propagated along the resin-fiber interface of one or the other of the two composites. From this observation, it may be assumed that the resin interface strength was greater than the adhesive strength of either of the composite systems.
